INTERACTION OF CONCRETE MASONRY BEARING WALLS AND CONCRETE
FLOOR SLABS

A THESIS

DEPARTMENT OF CIVIL ENGINEERING

SPRING 1979

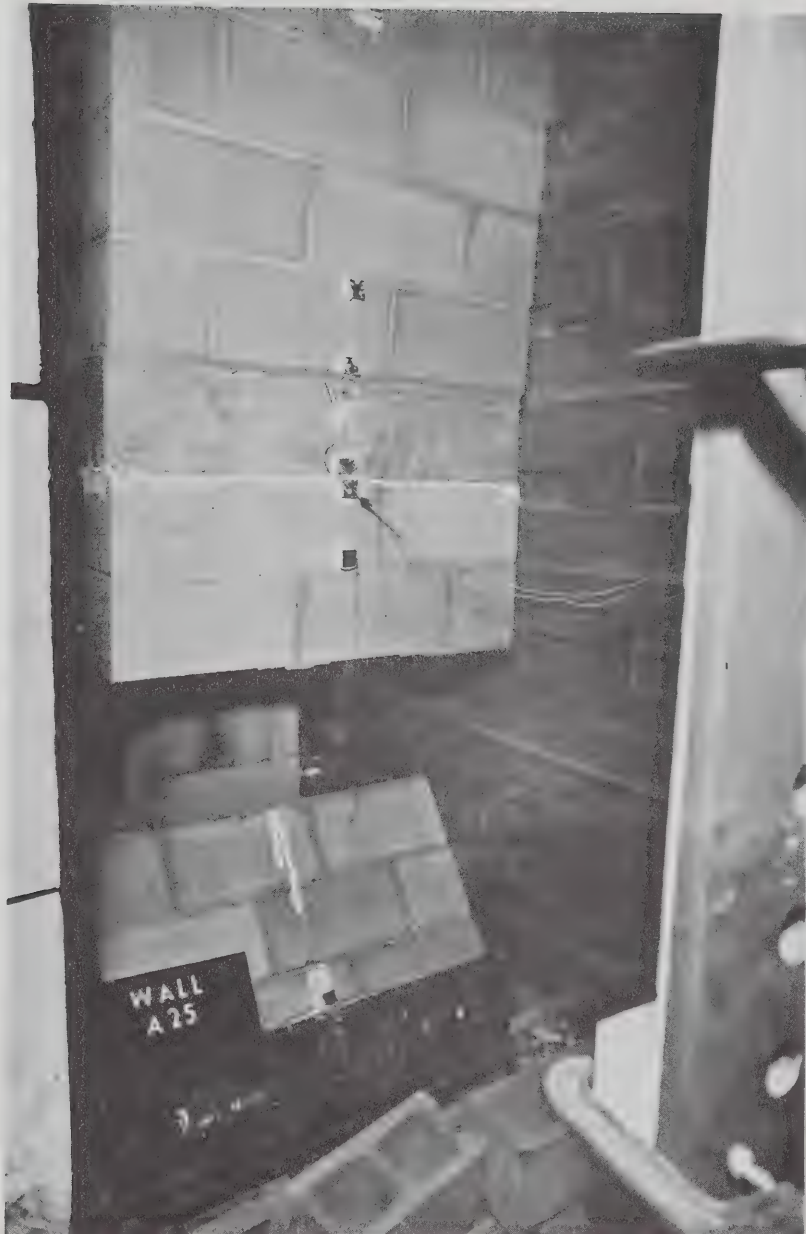
Plate 4.1 Wall A25 At Failure

The walls subjected to a low axial load had a tension type failure. After approximately 80% of M_{max} (the maximum applied moment which the joint was able to resist) was introduced into the system, a crack opened at the mortar joint above the slab on the tension side of the wall. The size of the crack increased with increasing moment until M_{max} was reached. The crack, at M_{max} , was more than 1/4 in wide and the rotation of the block above the slab no longer followed the rotation of the slab end.

A photograph of wall A25 at failure, a typical tension type failure, is presented in Plate 4.1. A photograph of wall A100 at failure, a typical compressive failure of an unreinforced wall, is presented in Plate 4.2 and a photograph of wall B150 at failure, a typical compressive failure of a reinforced wall, is presented in Plate 4.3.

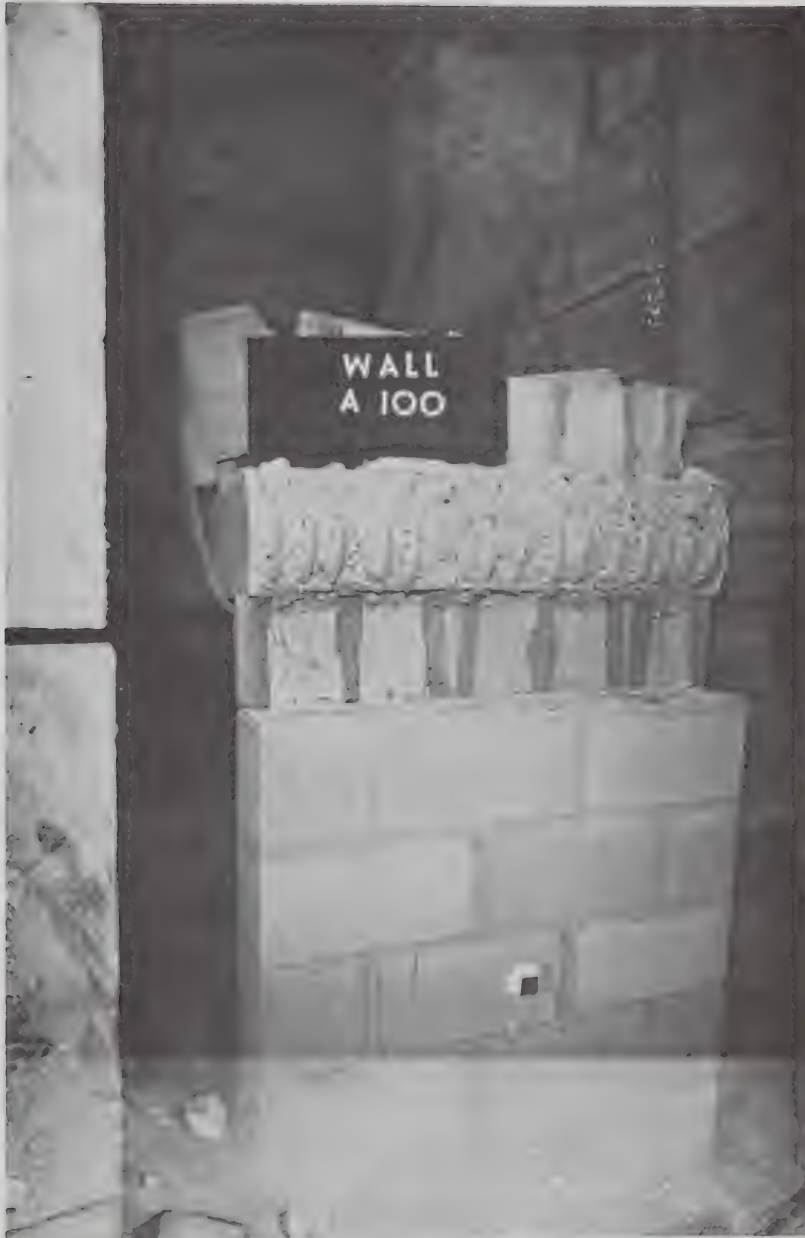
Plate 4.2 Wall A100 At Failure

Upon reaching Mmax the walls immediately failed. The unreinforced walls failed by vertical splitting of the upper wall extending from the slab to the top block. The reinforced walls failed by vertical splitting of only the block above the slab with the compression side of the block falling away from the specimen. For both the reinforced and unreinforced walls a large amount of concrete spalled from the slab.

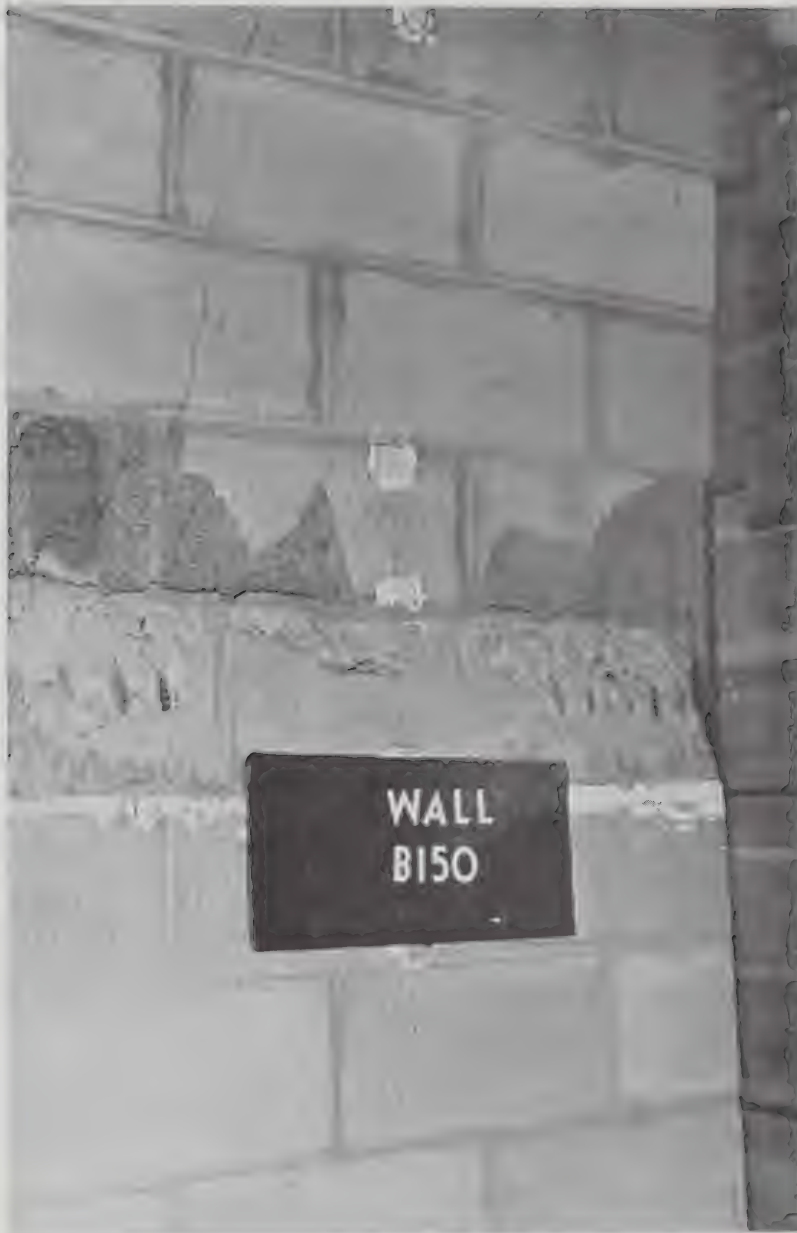
Plate 4.3 Wall B150 At Failure

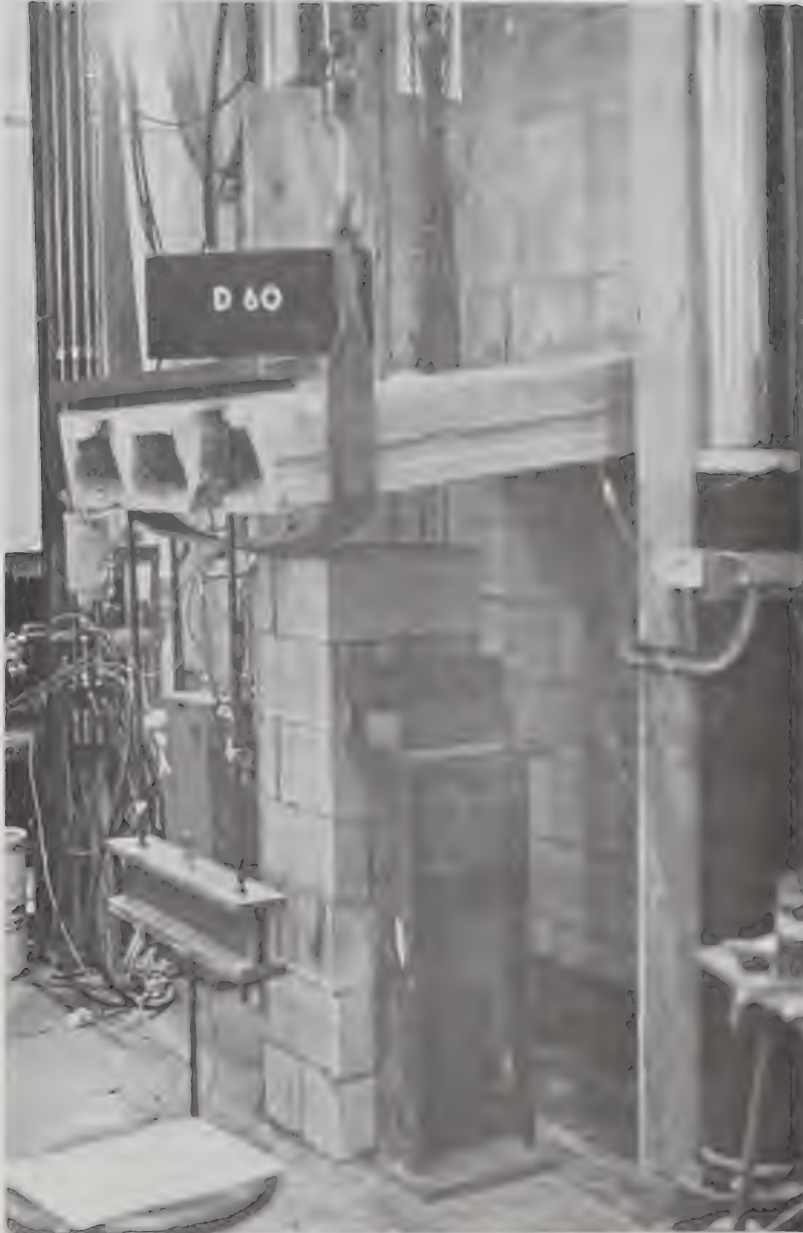
Plate 4.4 Wall D60 At Failure

The moment versus slab rotation relationships for all of the specimens with precast slabs are summarized in both tabular and graphic form in Appendix A. A photograph of wall D60, having a joint reinforced with wrap-around bars and two foot long vertical bars, at failure is presented in

A large slab deflection occurred as soon as the slab supports were removed. As M_{max} was reached a vertical crack opened at the precast slab end and a horizontal crack appeared along the mortar joint at the top of the slab. The deflection of the slab was increased and the joint was able to resist some moment. This continued until the tops of the vertical bars began pushing through the face of the wall.
